OROVILLE SPILLWAYS RESPONSE & RECOVERY 2017-2018

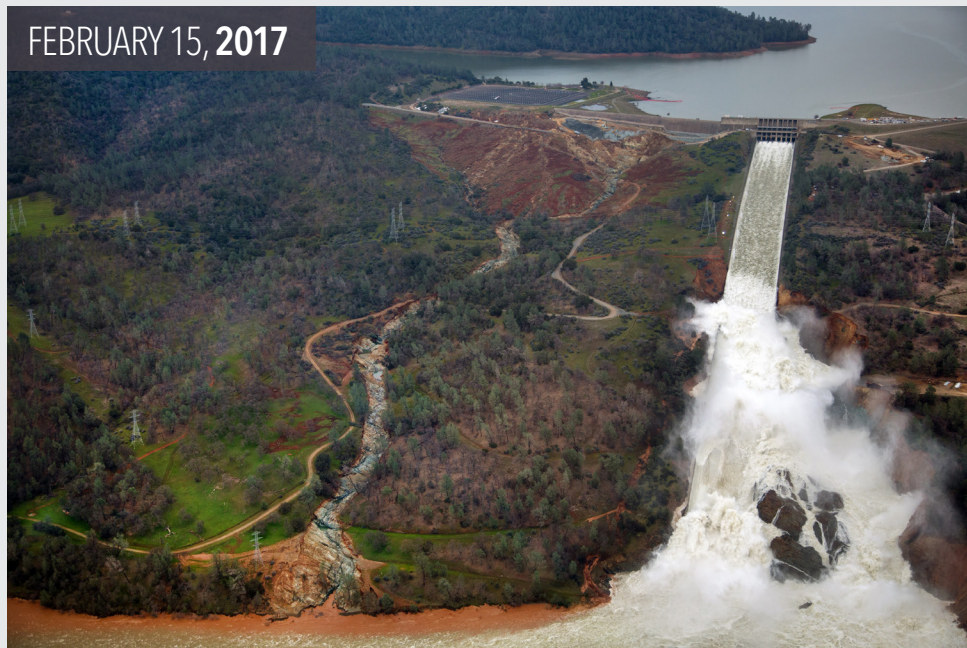
FEBRUARY 15, 2017

Lake Oroville damaged main spillway with an outflow of 100,000 (cfs).

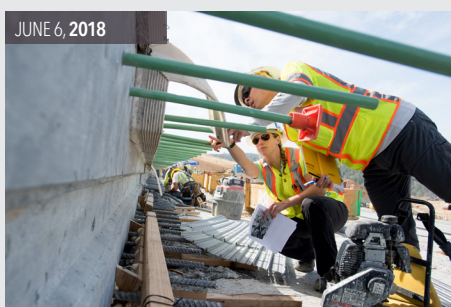
JUNE 6, 2018

Inspection work. DWR engineers check the leading edge of the upper chute where new structural concrete work will be poured on main spillway.
